EFFECTS OF SEISMIC RETROFITTING ON REINFORCED CONCRETE BUILDINGS SUFFERED DURING THE 2004 MID NIIGATA PREFECTURE EARTHQUAKE

Yoshimasa Honda¹, Daisuke Kato² and Yukiko Nakamura³

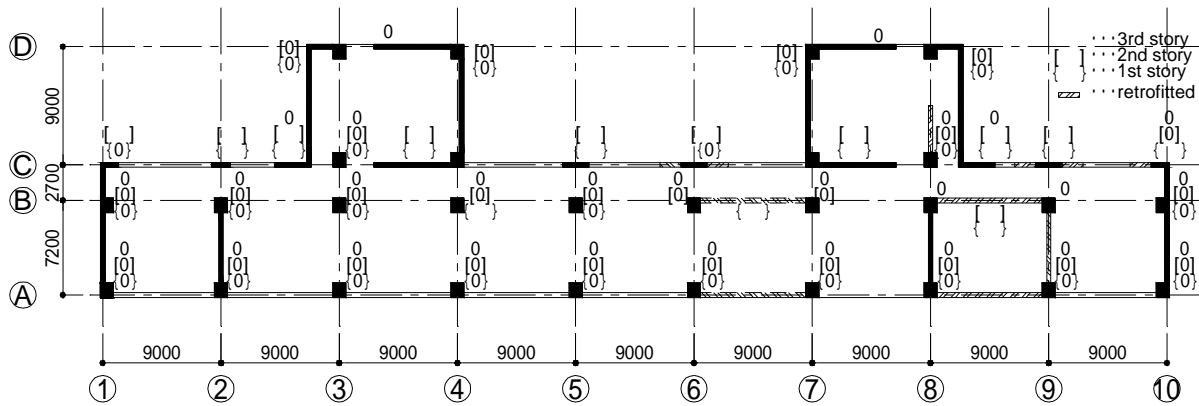
Figure 3. Damage level of column and wall members (TS-1 building of TS-High school)

Figure 3 shows observed damage level of all members of this building evaluated according to Ref. [2]. Damage level is classified under 5 levels, i.e. : slight damage, : light damage, : moderate damage, : heavy damage and : collapse. Damage level of 1st floor member is listed at the bottom part of damage level group of each member. Two columns with damage level of were observed in C frame of the first floor. Also two columns with damage level of were observed in C frame of the second floor. Photo 2 shows an example of columns with damage level of in the second floor indicating shear failure and buckling of main bars. This column is a rectangular column and the column height becomes short due to deep beams connecting to this column. Damage of columns in A frame and B frame were not observed but slight damage such as hair cracks around opening of walls of C frame were observed.

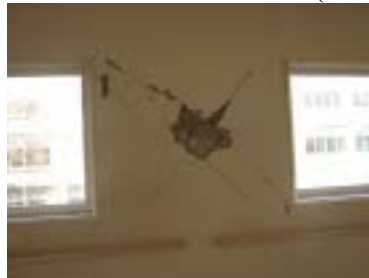
Photo 2. Damage of column (damage level) of 2nd floor (TS-1 building of TS-High school)

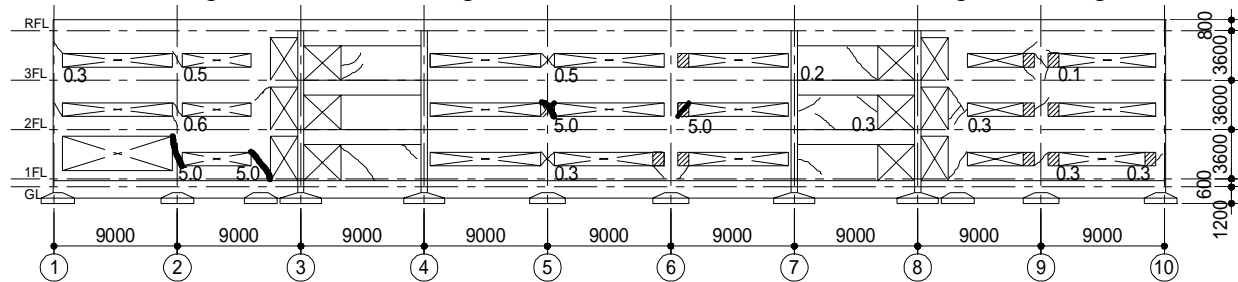
Figure 4. Crack pattern of C frame (TS-1 building of TS-High school)

Figure 4 shows observed crack patterns of C frame indicating crack width in mm unit. Maximum crack width of columns with damage level of was 5 mm. Those crack patterns

indicate that crack width of non retrofitted columns and columns retrofitted by one side wall on one side only is larger than that of columns retrofitted by two side walls on both sides, which means the use of retrofitting by sidewalls.

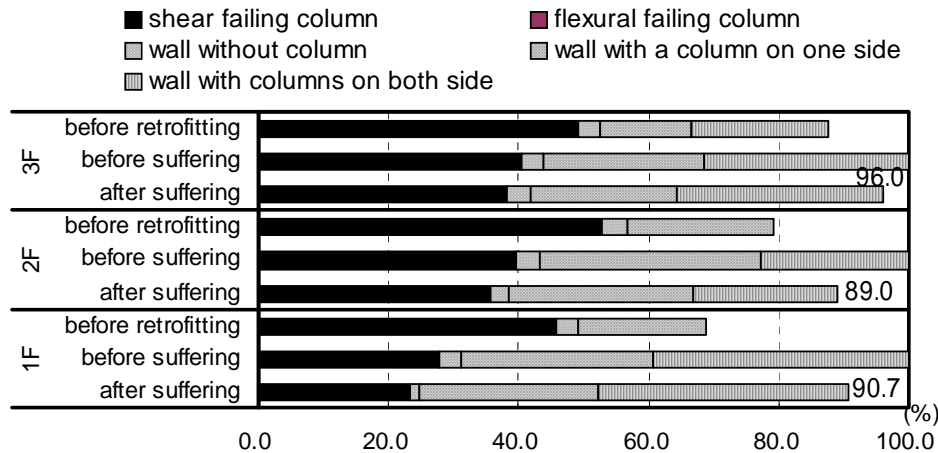
Figure 5. Remaining ratio of seismic performance of building in the long span direction (TS-1 building of TS-High school)

Remaining seismic performance of the building can be evaluated using damage levels of members shown in Fig. 3. Figure 5 shows evaluated remaining seismic performance of this building calculated according to Ref. [2]. Remaining seismic performance is expressed by ratio of seismic performance of damaged building to that of original non damaged building. In Fig. 5 ratio of seismic performance of building before retrofitting is also shown for comparison.

Figure 5 indicates that remaining seismic performance of second floor was 89% of original building, which was classified into light damage according to Ref. [2]. Note that seismic performance of this building before retrofitting was lower than that of present damaged building, which indicates that damage level would be worse if this building was not retrofitted.

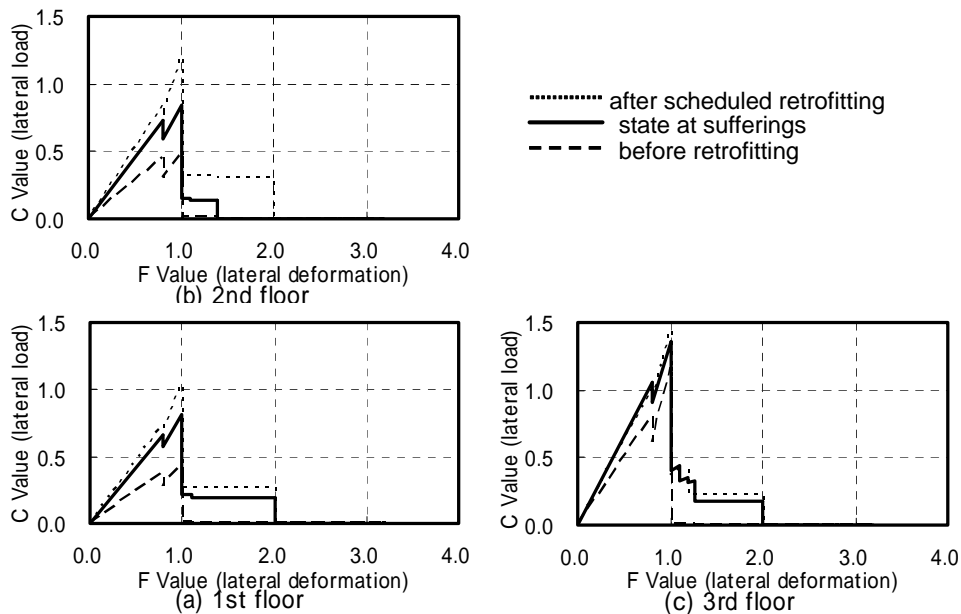
Figure 6. Relation between C Value and F Value (TS-1 building of TS-High school)

Figure 6 shows evaluated relations between C value and F value, which represents the relations between lateral load and lateral deformation of the floor. Relations of three states depending on the retrofitting process are shown in each figure; i.e. non retrofitted original building, partly retrofitted present state and imaginary state after scheduled retrofitting. Using these relations seismic performance indices I_s of the present state were obtained as shown in Table 2. On the other hand seismic safety of a building is judged by seismic judgment index I_{SO} shown as follows.

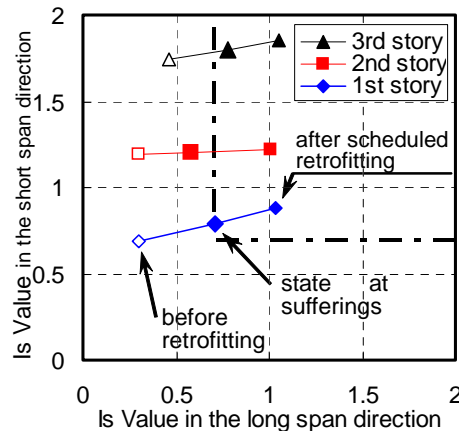
Figure 7. I_s Value (second level evaluation) (TS-1 building of TS-High school)

Figure 7 shows relations of I_s values between long span direction and short span direction. Relations of three states depending on the retrofitting process shown in Fig. 6 are also compared in this figure. Broken lines in this figure represent required I_{S0} value for school buildings(0.7). This figure indicates that evaluated I_s values of non retrofitted original building in the long span direction are much smaller than the required value and I_s value of the second floor of the present building with partly retrofitting is also smaller than the required value. This can explain the fact that the damage of the second floor of the building was severer than other floors. And it should be noted that I_s values of imaginary building after scheduled retrofitting are large enough in both directions which means that this building could survive during the earthquake without any damage if scheduled retrofitting had been completed.

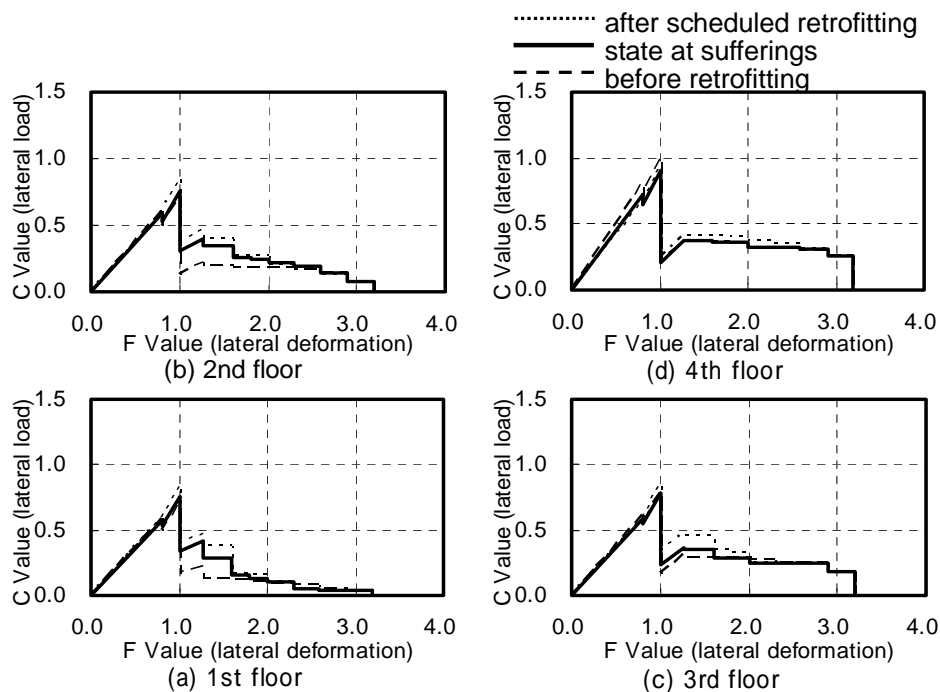
Figure 10. Relation between C Value and F Value (T-1 building of T-High school)

Figure 10 shows evaluated relations between C value and F value. Relations of three states depending on the retrofitting process are shown in each figure; i.e. non retrofitted original building, partly retrofitted present state and imaginary state after scheduled retrofitting. Using these relations seismic performance indices I_s of the present state were obtained as shown in Table 4.

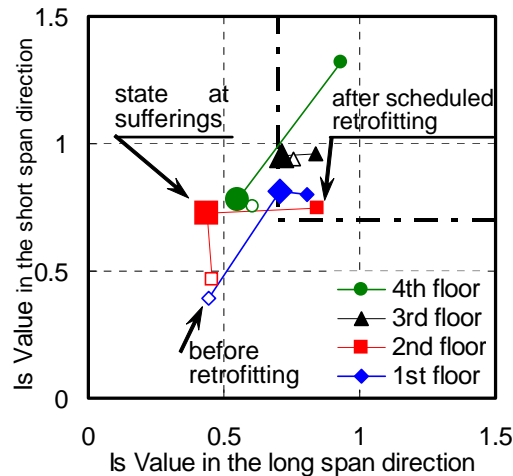
Figure 11. I_s Value (second level evaluation) (T-1 building of T-High school)

direction. Relations of three states depending on the retrofitting process shown in Figure 10 are also compared in this figure. Broken lines in this figure represent required I_{SO} value for school buildings(0.7). This figure indicates that evaluated I_s values of the 1st, 2nd and 4th floor of non retrofitted original building in the long span direction are smaller than the required value and I_s values of the 2nd and 4th floor of the present building with partly retrofitting are also smaller than the required value. But the damage of the 2nd and 4th floor was negligible. It is necessary to verify the relation between the negligible damage and the small I_s value.
