EFFECTS OF SEISMIC RETROFITTING ON REINFORCED CONCRETE BUILDINGS SUFFERED DURING THE 2004 MID NIIGATA PREFECTURE EARTHQUAKE

Yoshimasa Honda¹, Daisuke Kato² and Yukiko Nakamura³

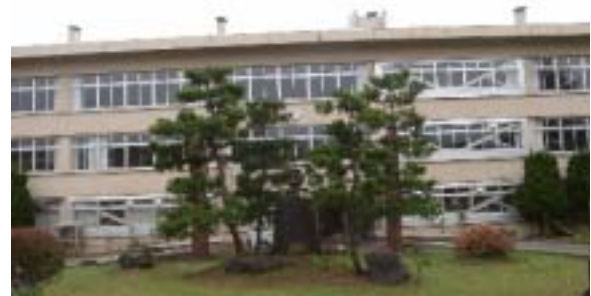
Photo 1. General view (TS-1 building of TS-High school)

In 2004 seismic performance of this building was evaluated according to Standard for Evaluation of Seismic Capacity of Existing reinforced Concrete Buildings [1] and seismic retrofitting plan was designed. Figure 2 shows the location of assumed installed steel braces, postcast reinforced concrete shear walls and postcast reinforced concrete side walls to enhance seismic performance of this building. However actual retrofitting construction was not completed when the earthquake occurred. Figure 2 shows that only right half of the retrofitting had been completed. Photo 1 shows installed steel braces of A frame of this building.

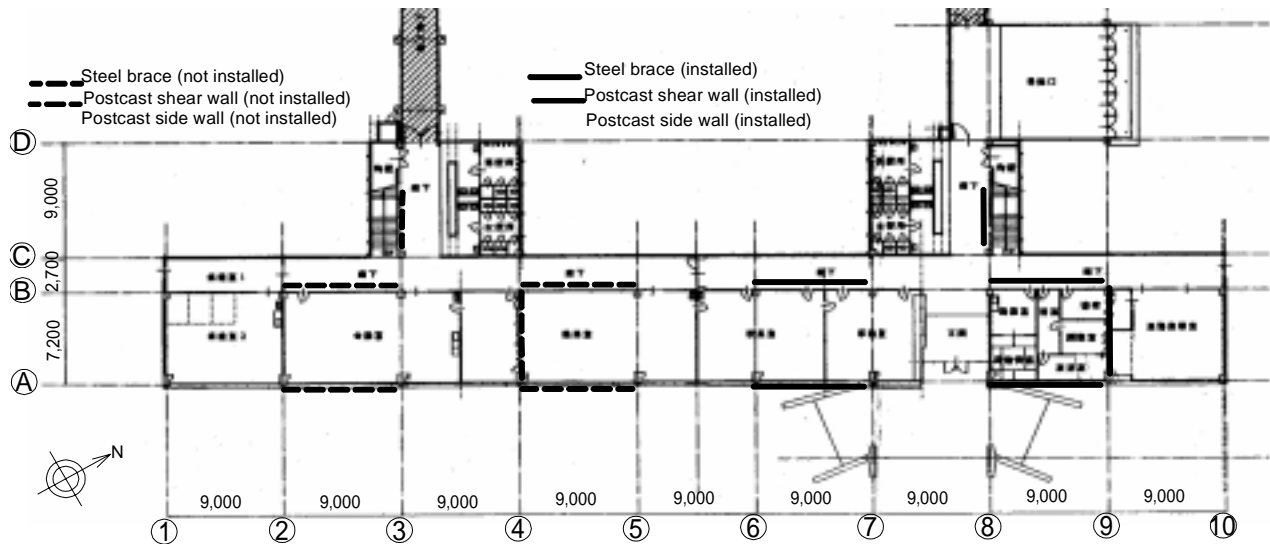
Figure 2. Plan of 1st floor (TS-1 building of TS-High school)

TS-High school is located 500m north of K-NET accelerometer. Table 1 shows outline of TS-1 building of this high school damaged lightly during this earthquake. This building was built in 1966 and 1967 according to former Japanese building law which was revised in 1981. Figure 2 shows plan of 1st floor of this building. This is a three story beam-column framed building and the main part of this building has nine bays in the long span direction and two bays in the short span direction. Although the cross section of columns of A frame and B frame is 500 cm ×

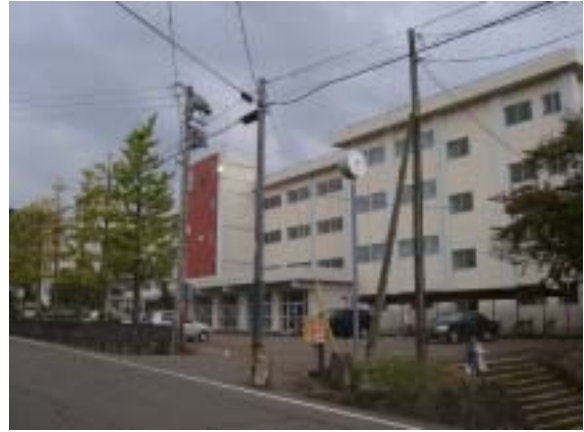
Photo 3. General view (T-1 building of T-High school)

T-High school is located 1200m east of K-NET accelerometer. Table 3 shows outline of T-1 building of this high school damaged negligibly during this earthquake. This building was built from 1973 to 1979 according to former Japanese building law which was revised in 1981. Figure 8 shows plan of 2nd floor of this building and figure 9 shows a framing elevation of G frame. This is a four story beam-column framed building and the main part of this building has twenty three bays in the long span direction and eight bays in the short span direction. The cross section of columns is 700cm X 450~500 cm. Photo 3 shows general view of this building.

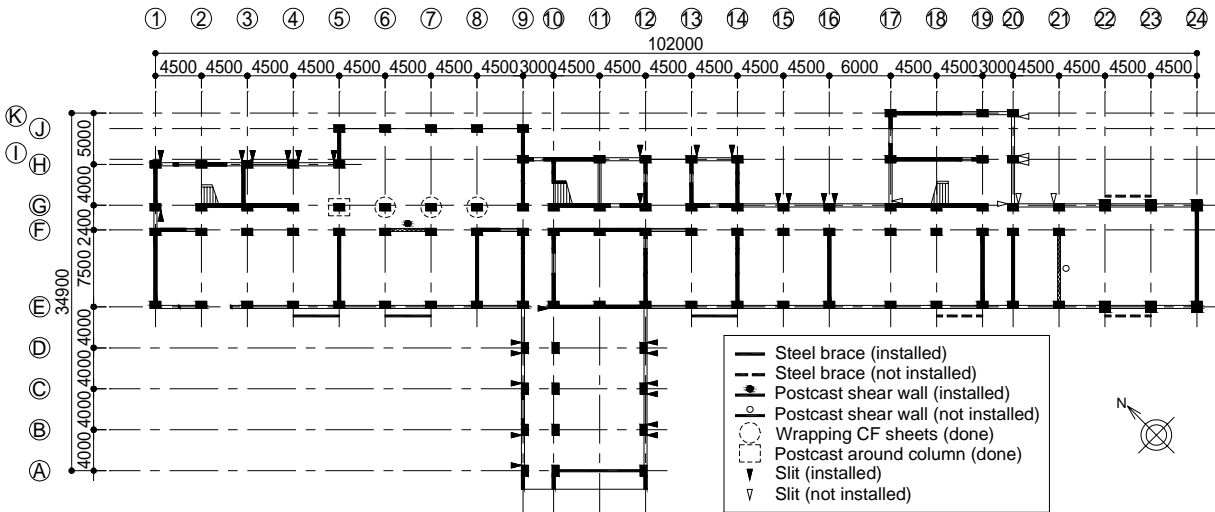
Figure 8. Plan of 1st floor (T-1 building of T-High school)

In 2003 seismic performance of this building was evaluated according to Standard for Evaluation of Seismic Capacity of Existing reinforced Concrete Buildings [1] and seismic retrofitting plan was designed. Figure 8 shows the location of assumed installed steel braces, slits in walls, wrapping CF sheets and new postcasted column around existing column to enhance seismic performance of this building. However actual retrofitting construction was not completed when the earthquake occurred. Figure 8 shows that only left half of the retrofitting had been completed.
